Re: Construction Settlement Issues (PCO #341)

## TECHNICAL MEMORANDUM

**Re:** Ground Settlement from Dewatering during Construction  
SR99 TBM Access Shaft  
Seattle, WA

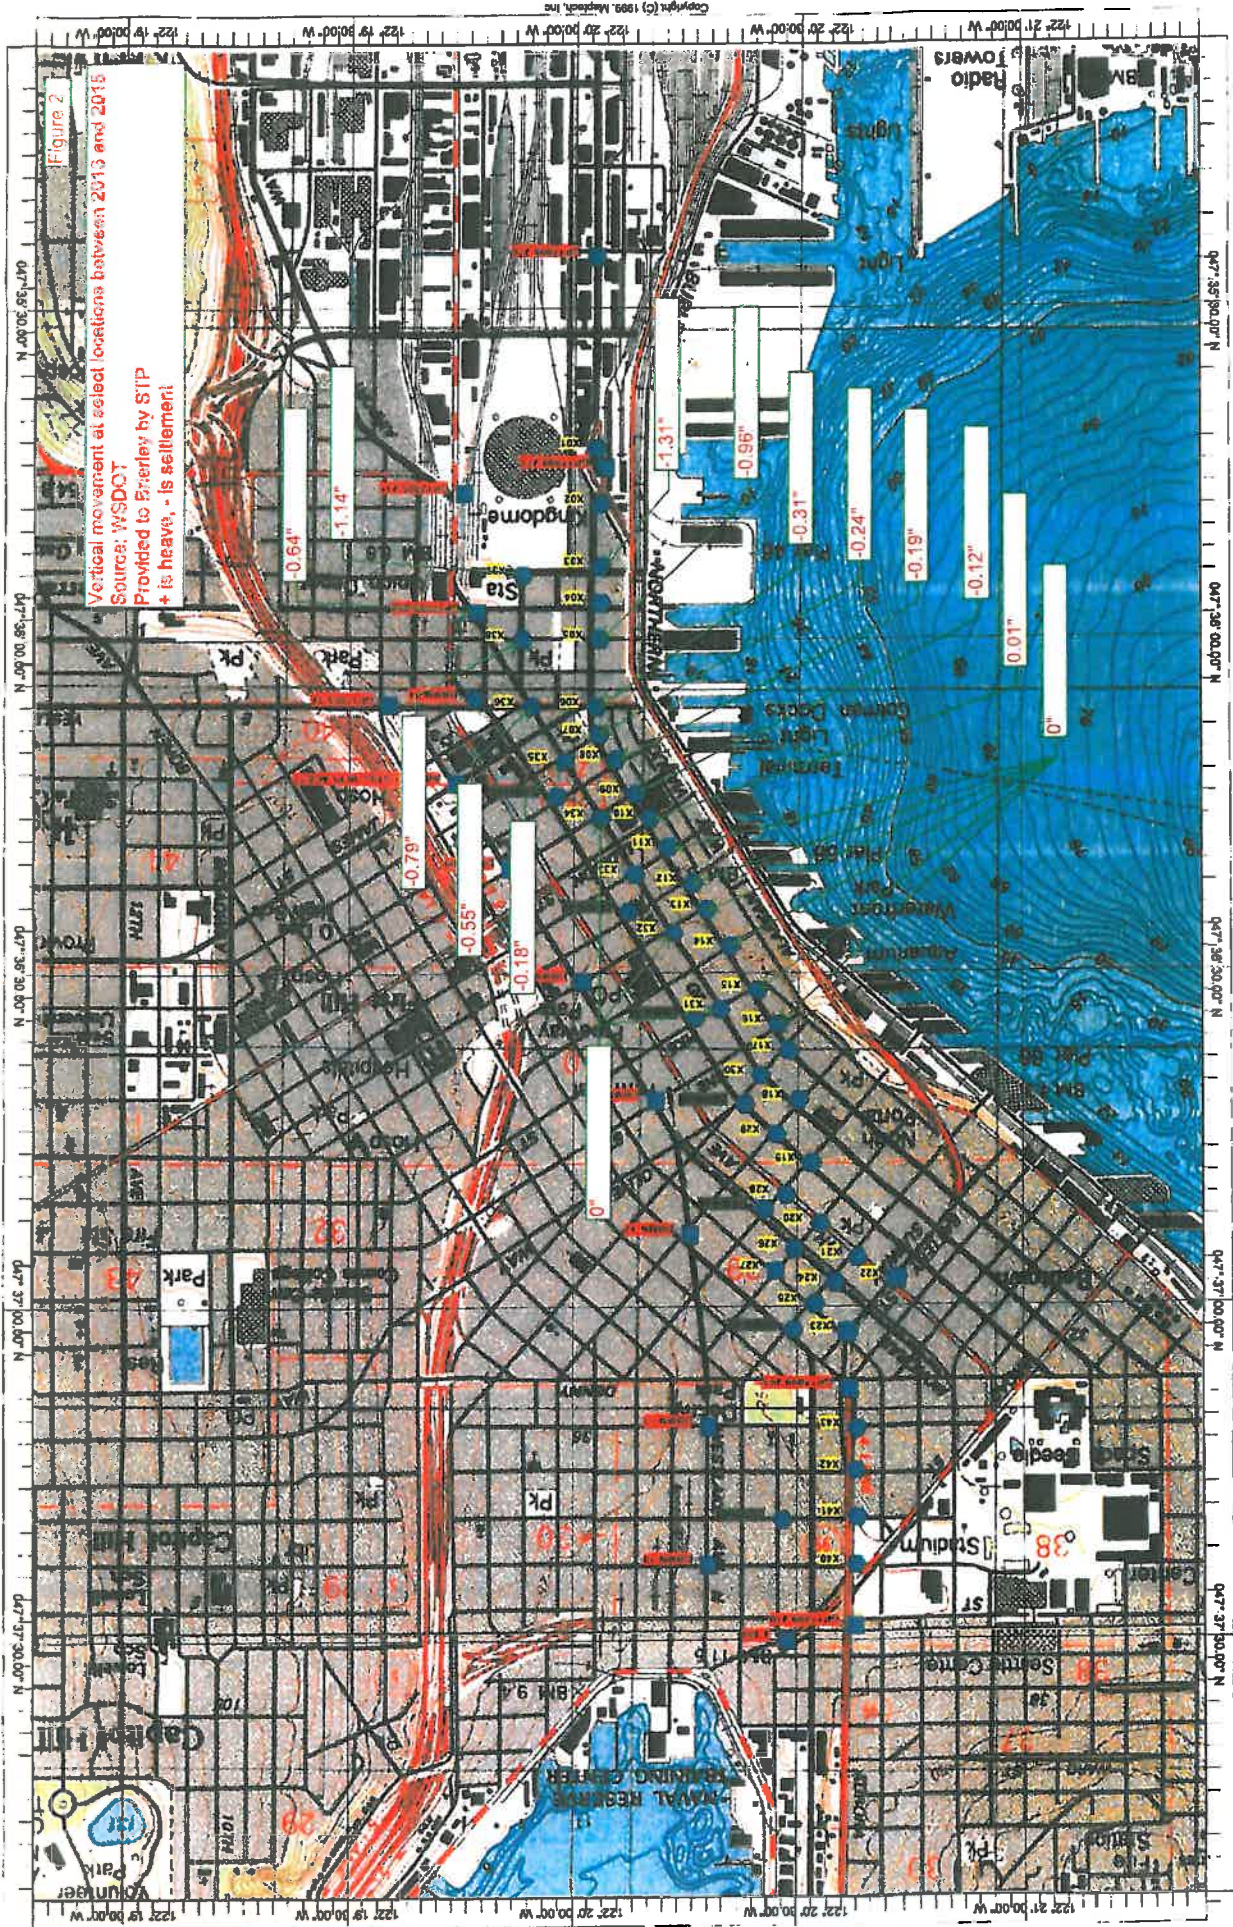
**REPORTED SURFACE MOVEMENT  
JULY 2012 TO NOVEMBER 5, 2014  
FROM SOLDATA ATLAS REPORT**

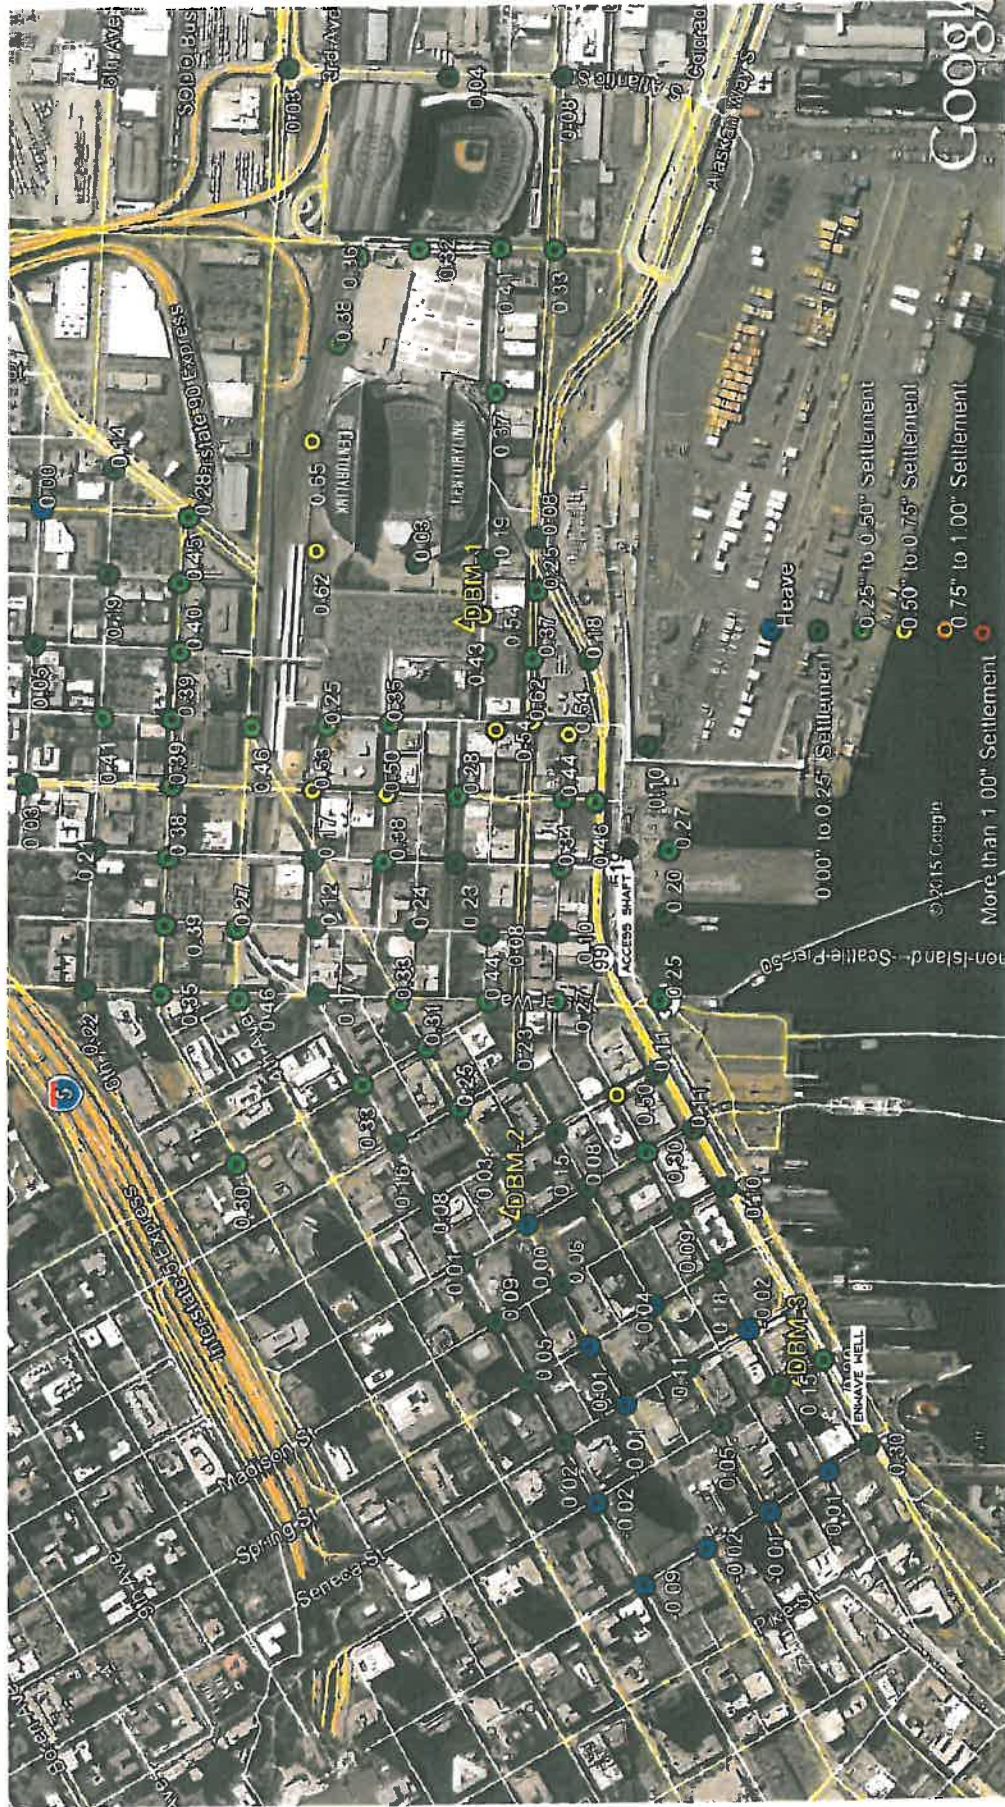
REPORTED SURFACE MOVEMENT  
NOVEMBER 5, 2014 TO DECEMBER 7,  
2014 FROM SOLDATA ATLAS REPORT

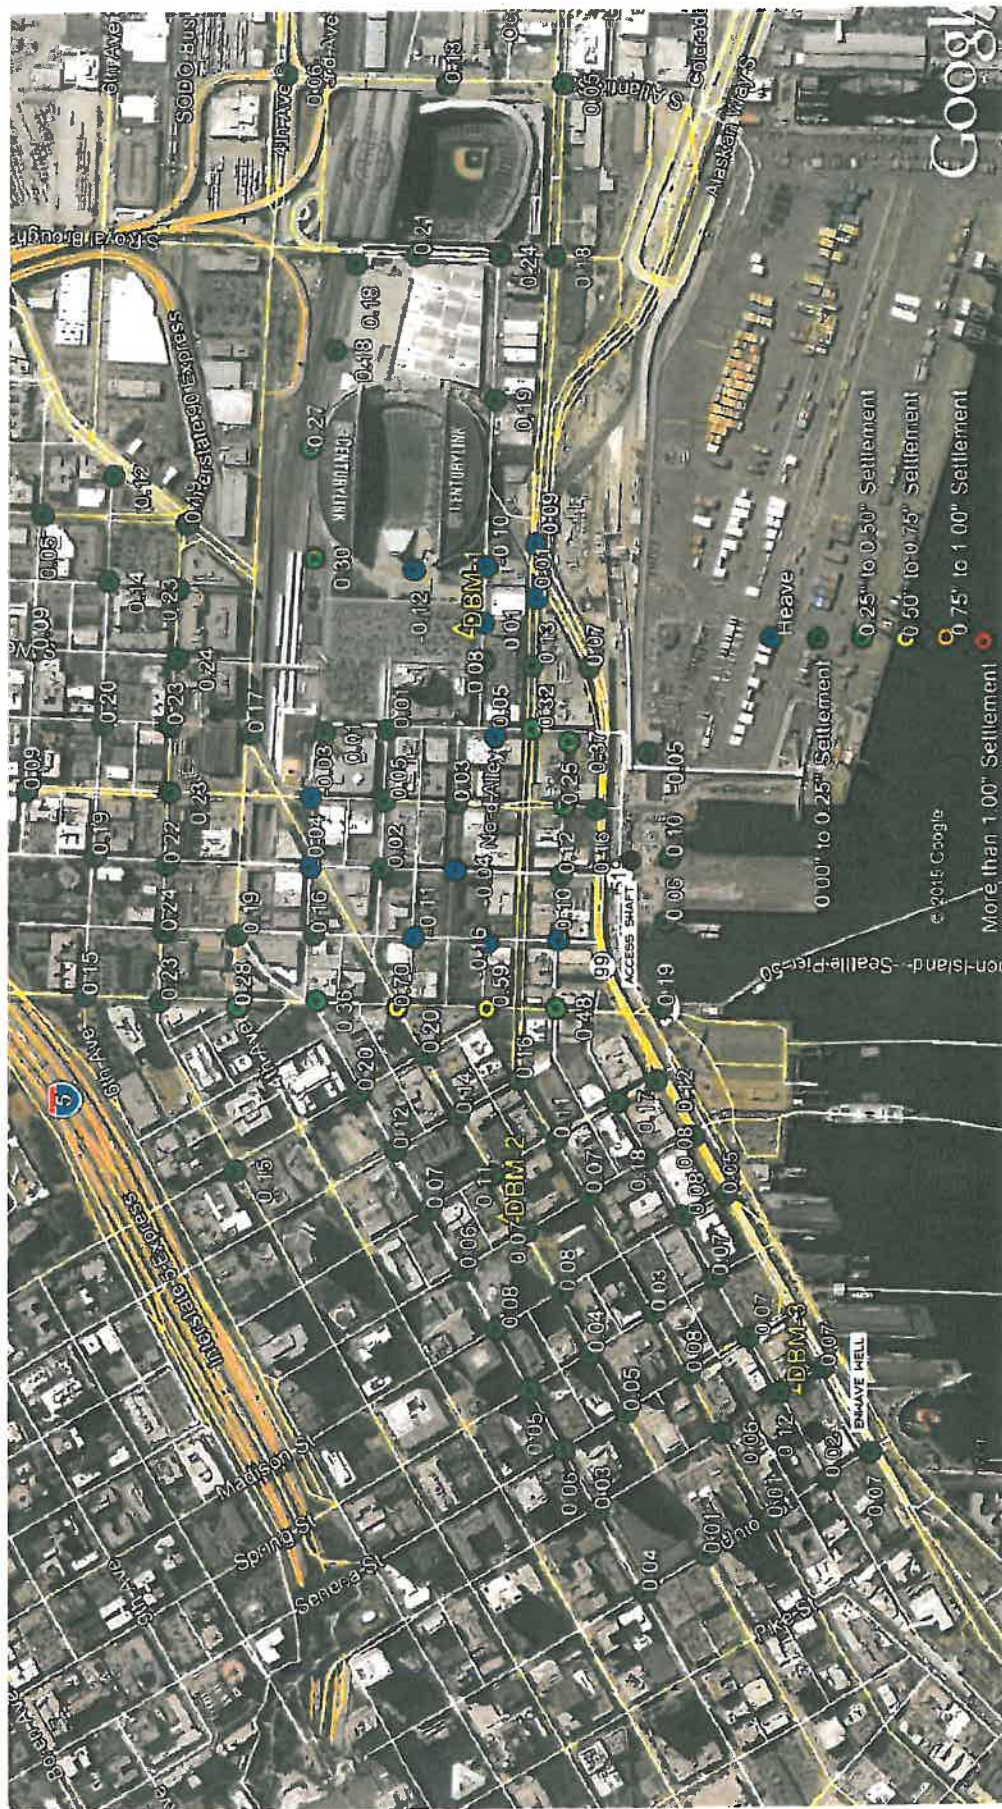
REPORTED SURFACE MOVEMENT  
DECEMBER 7, 2014 TO FEBRUARY 9,  
2015 FROM SOLDATA ATLAS REPORT

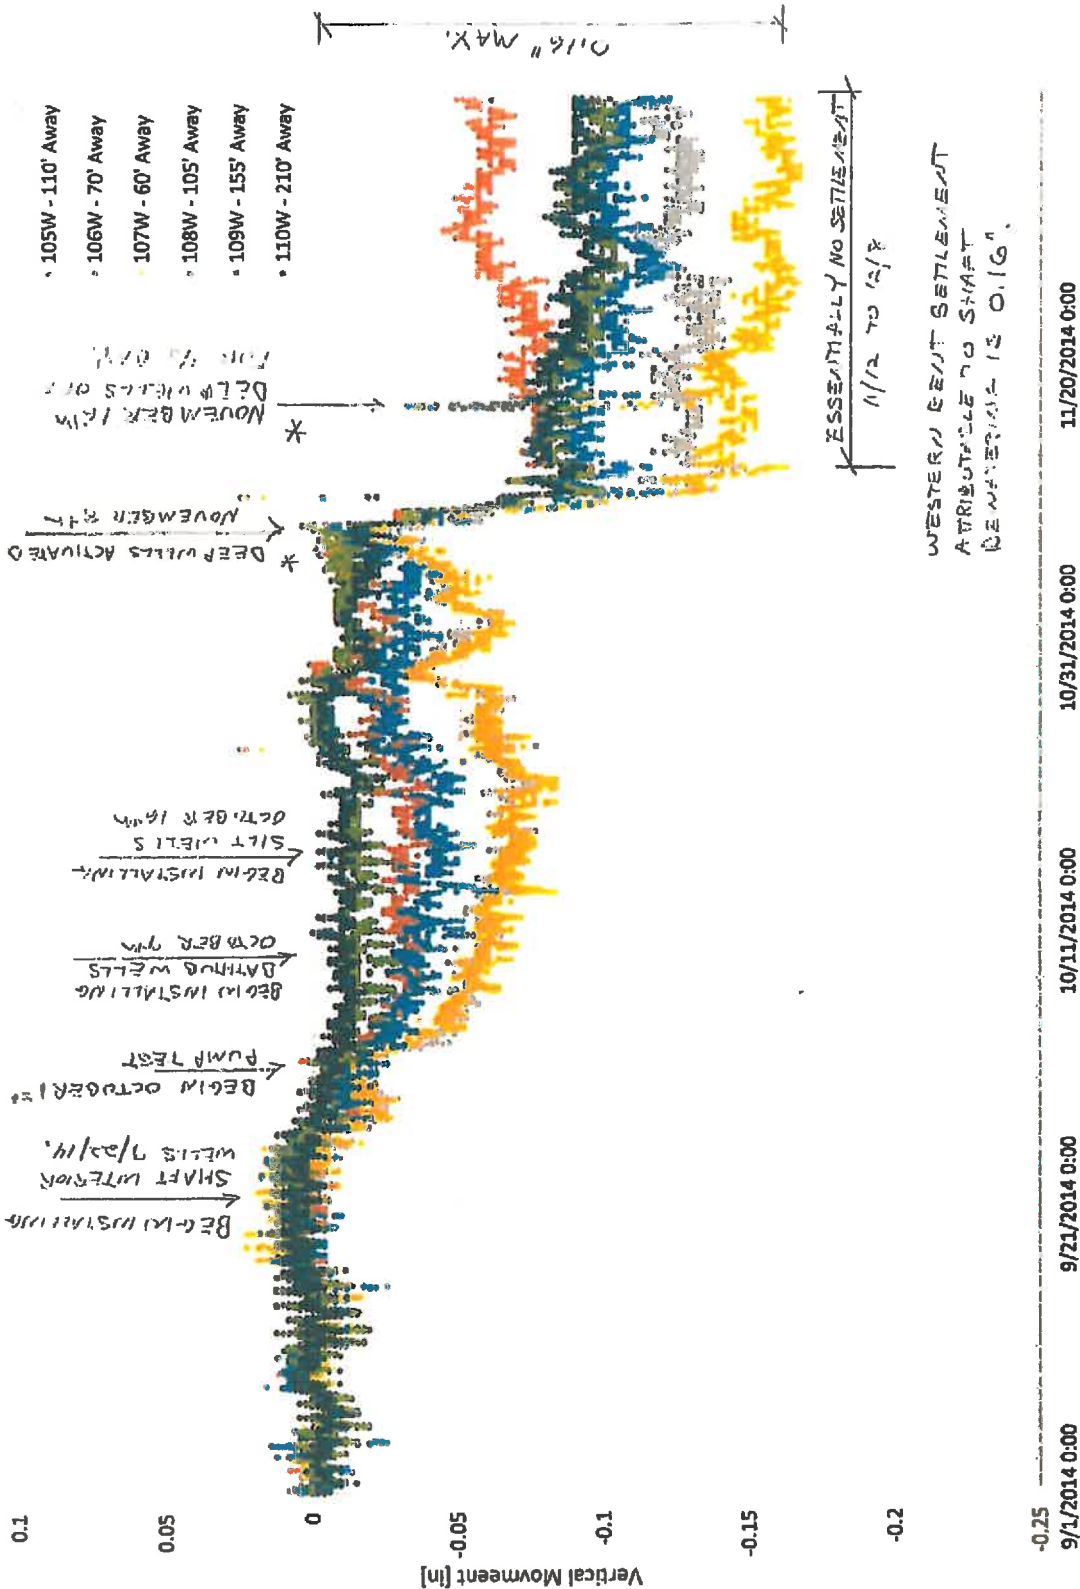
Western Bent Settlement Data 9/1 to 12/9 - Rezeroed About 9/1 to 9/21 Average

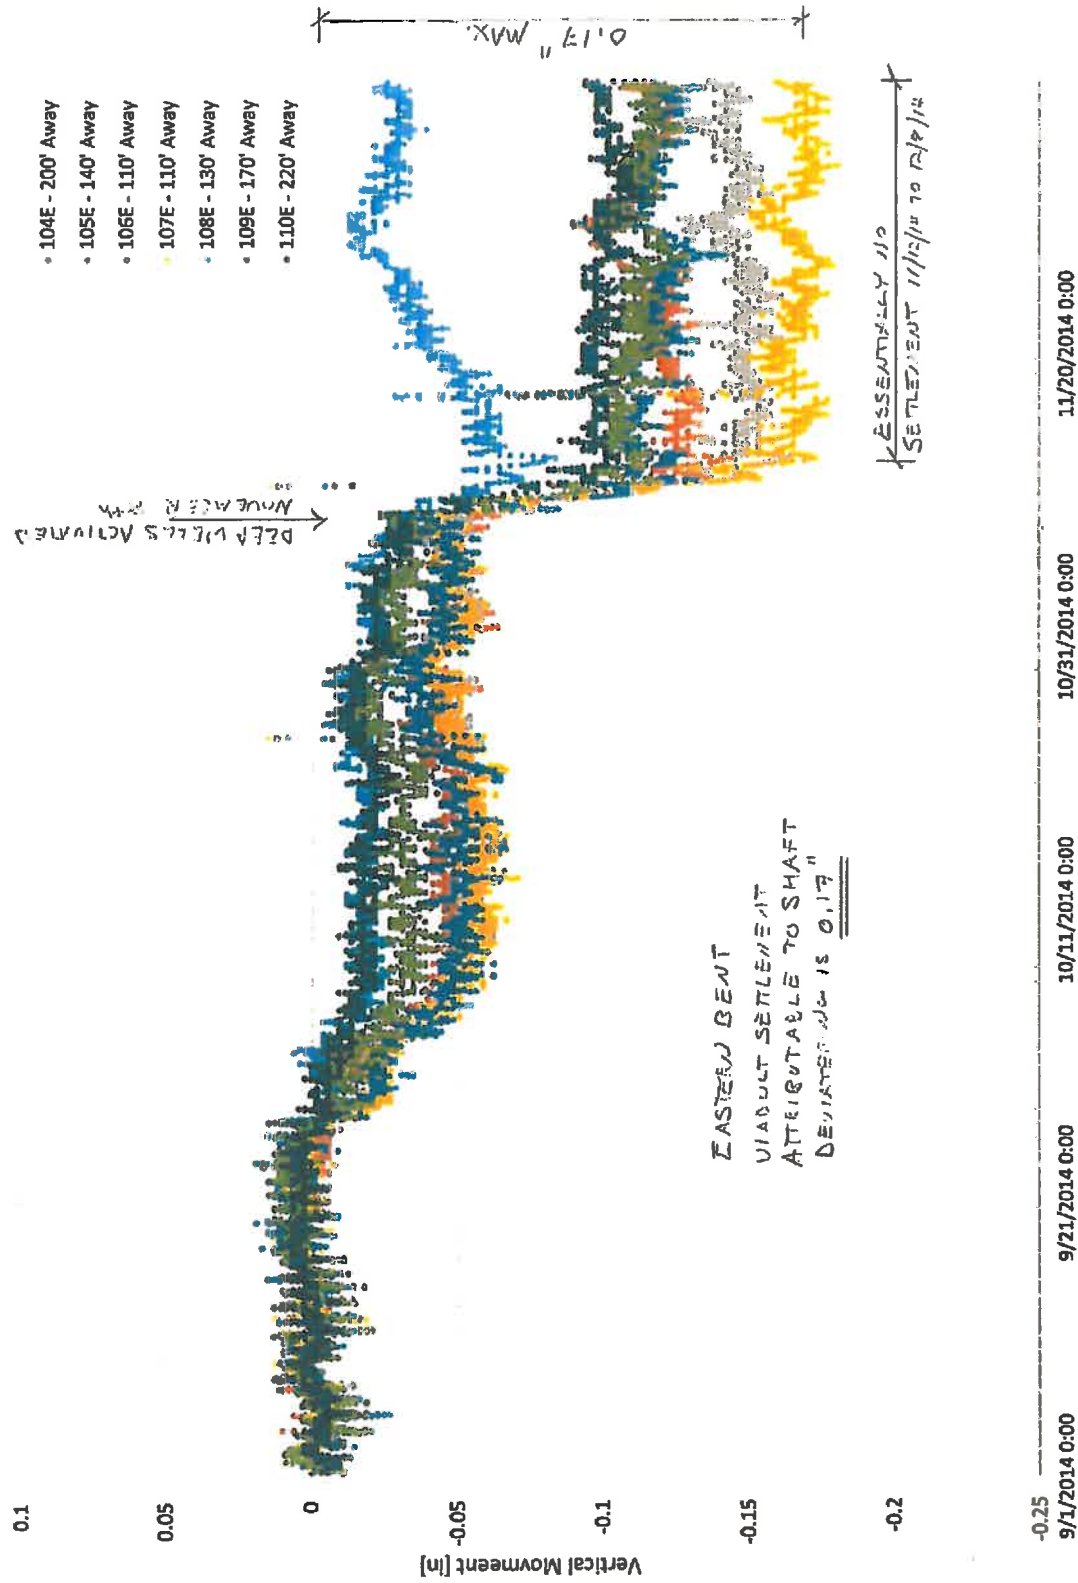
# Eastern Bent Settlement Data 9/1 to 12/9 - Rezeroed About 9/1 to 9/21 Average

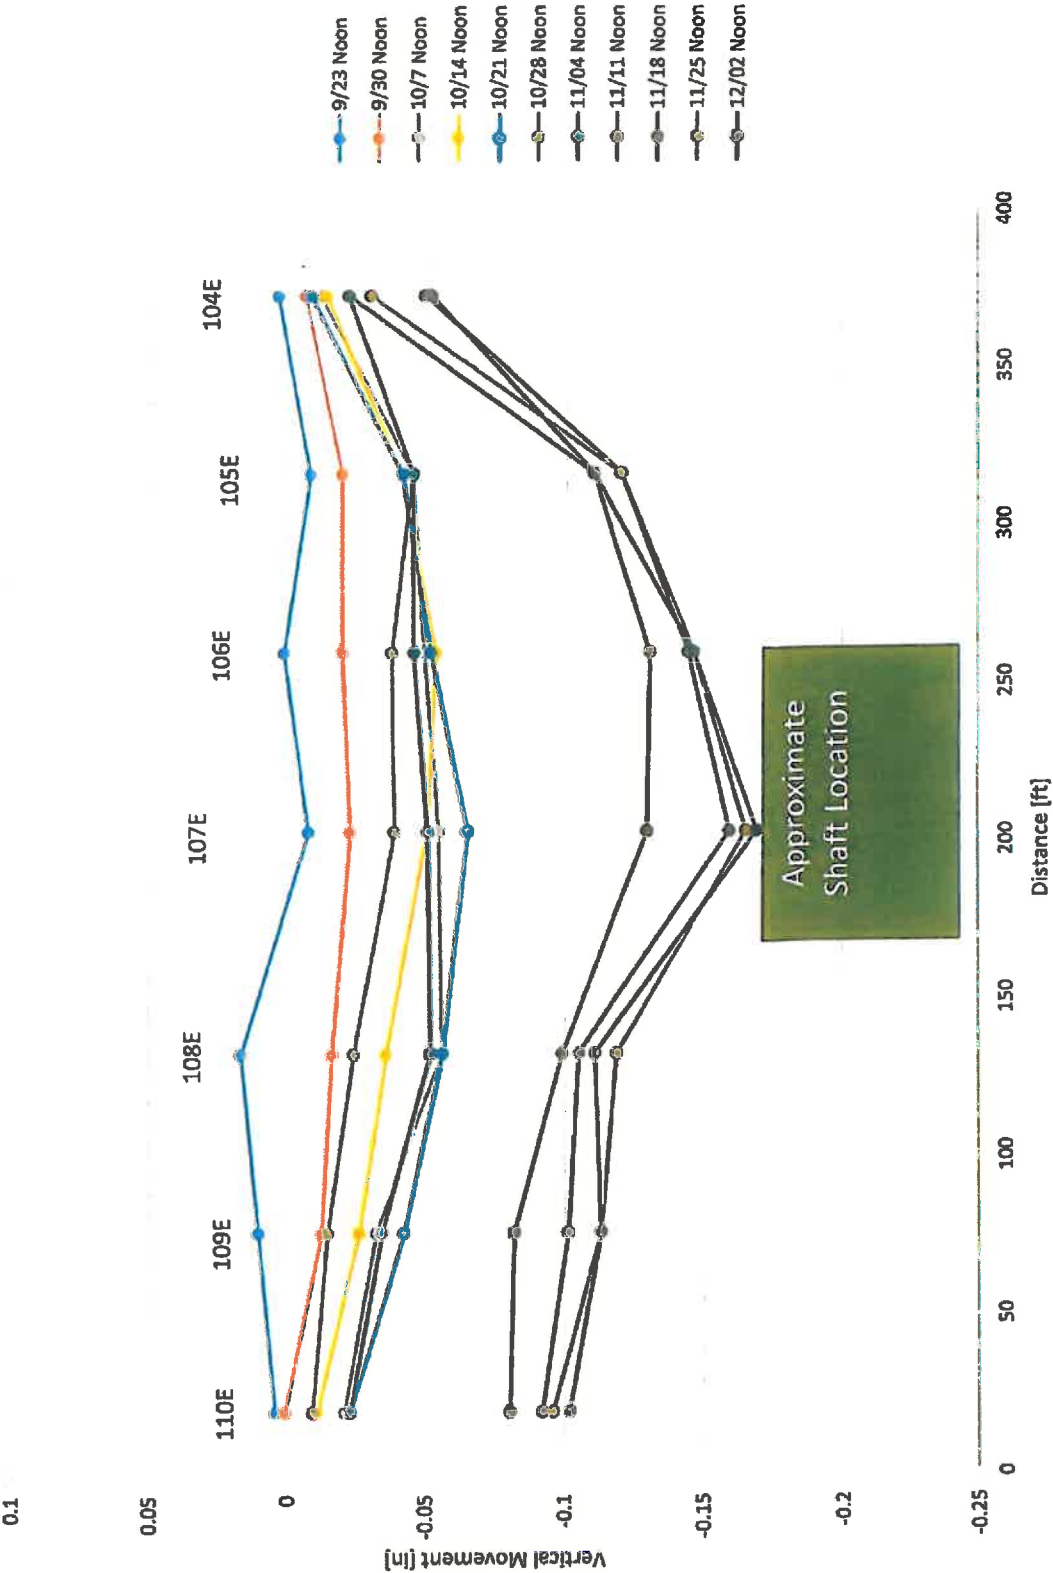
Settlement Along AWW per Time (Bent 110E to Bent 104E)
